SAGE CREEK SPRINGS WORKSHOP

TOUR OF THE RAWLINS WATER SUPPLY

## RAWLINS GROUNDWATER SUPPLY FIELD VISIT AGENDA

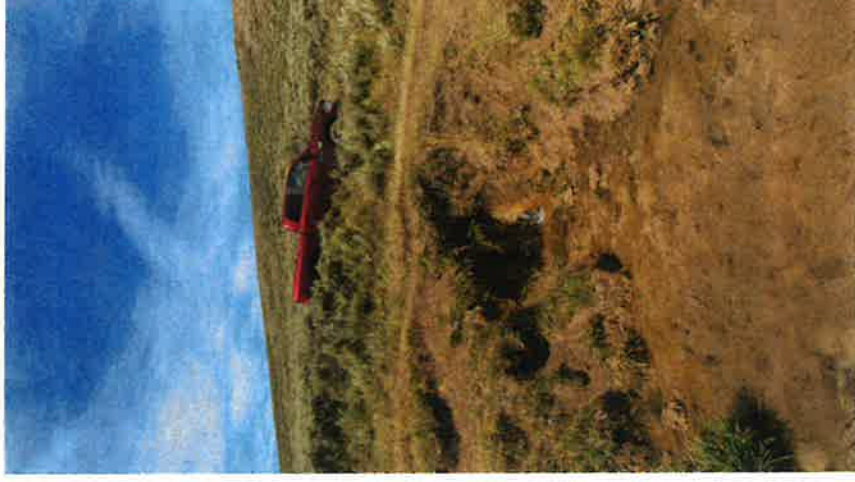
8/11/21  
Leak No. 1 on Sage  
Creek Wood Stave  
Collection.  
Segment No. 200

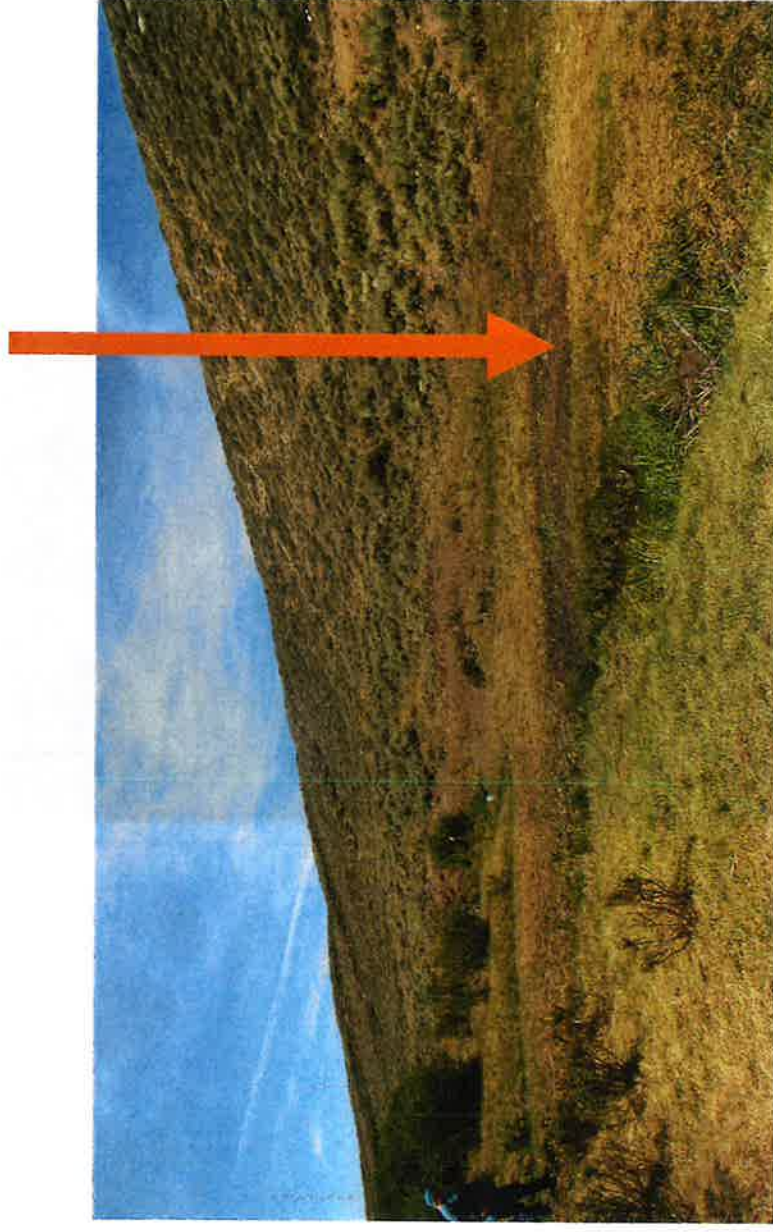
8/11/21  
Leak No. 2 on  
Sage Creek  
Wood Stave  
Collection.  
Segment No.  
200

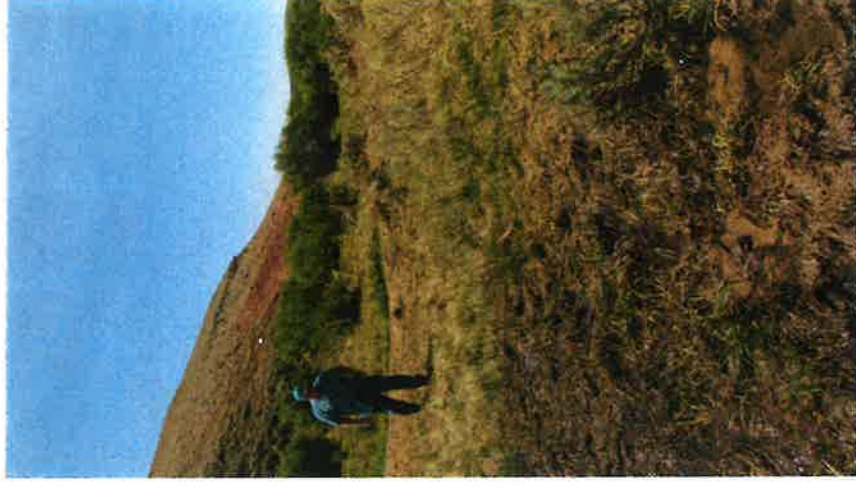
8/11/21  
Leak No. 2 on  
Sage Creek  
Wood Stave  
Collection.  
Segment No.  
200

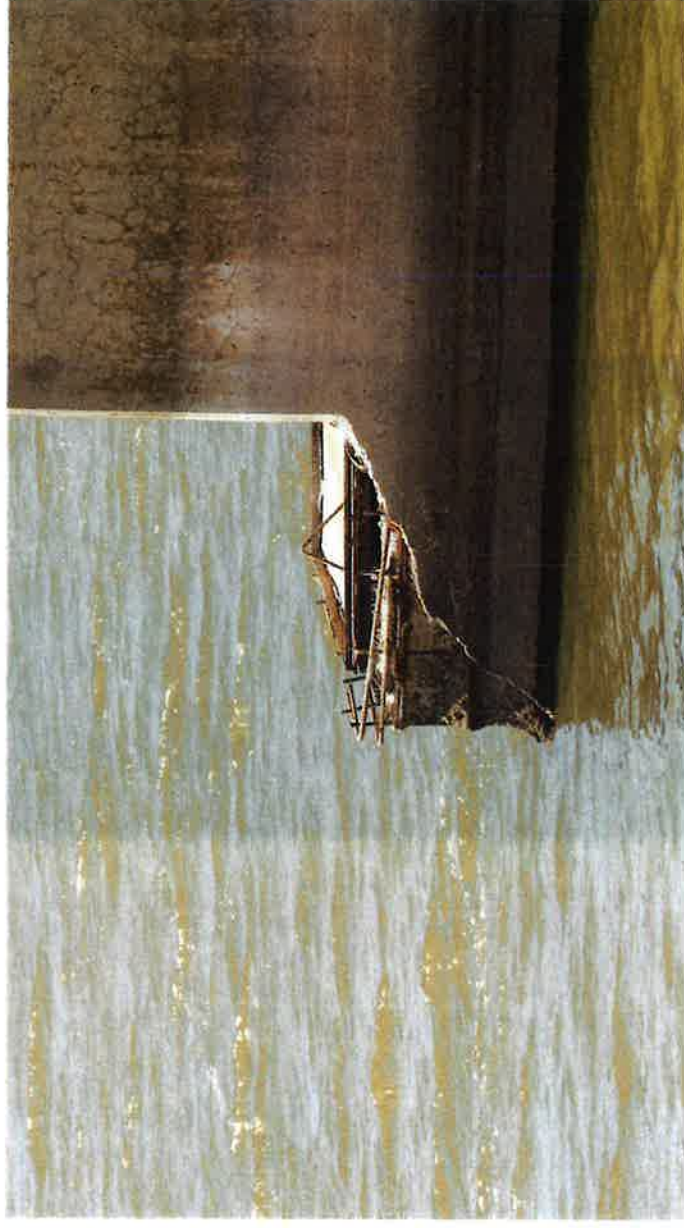
8/11/21  
Rawlins  
Reservoir view  
from Dam to  
West and  
Damaged  
Outlet Tower

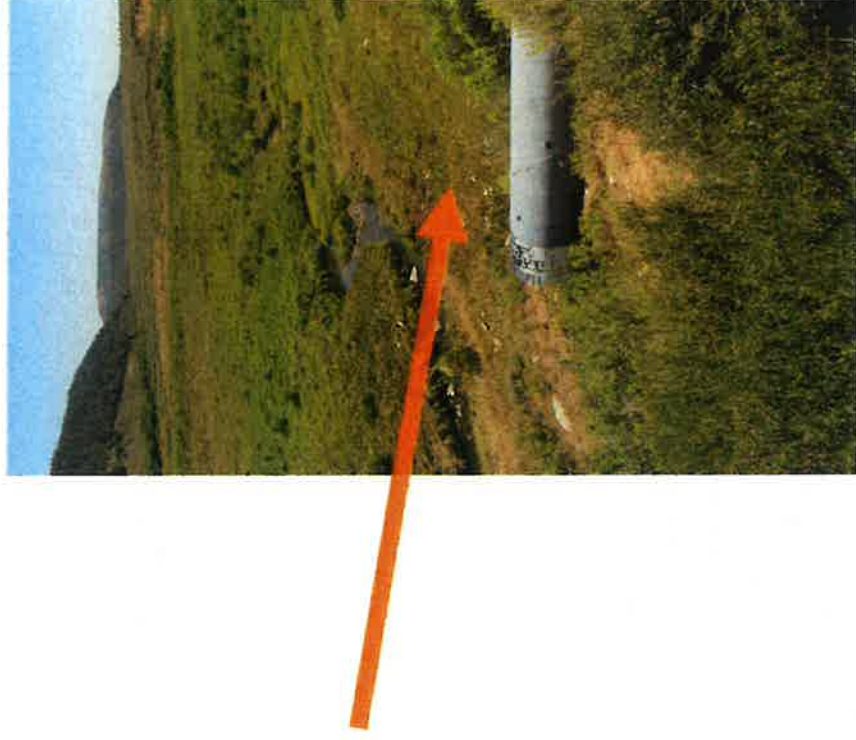
8/11/21  
Leak?  
Below junction  
box Sage &  
Beaver Creeks.  
Pipe is vault  
spillway.  
View SW

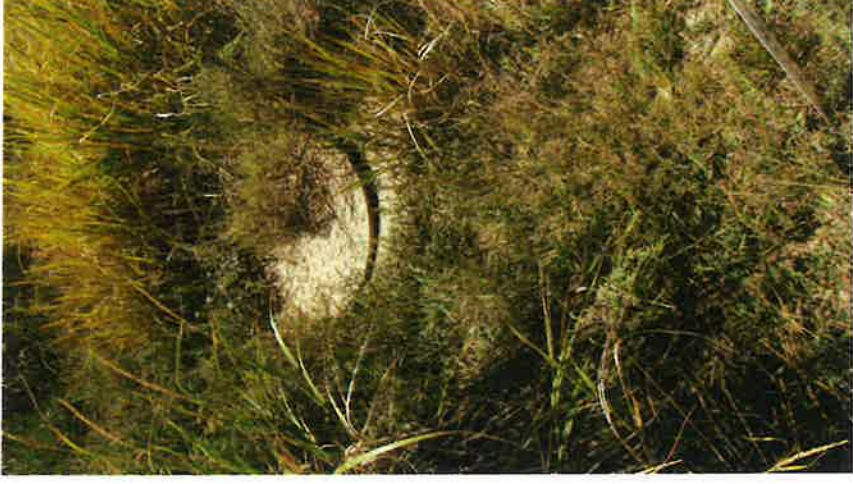
8/11/21  
Unnamed  
Creek Blowoff  
Valve  
Damaged but  
not leaking  
blow off valve  
No. 18

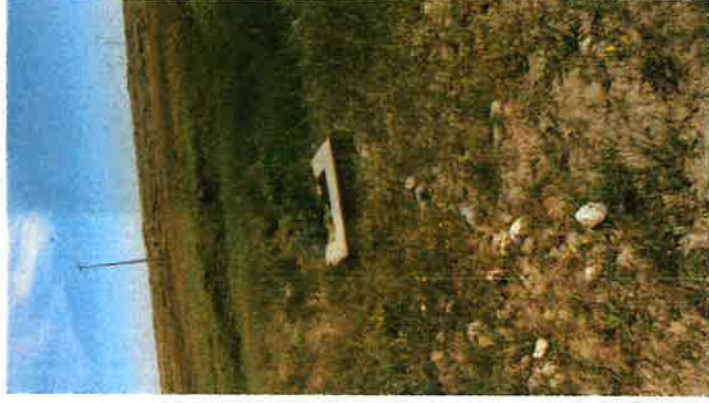
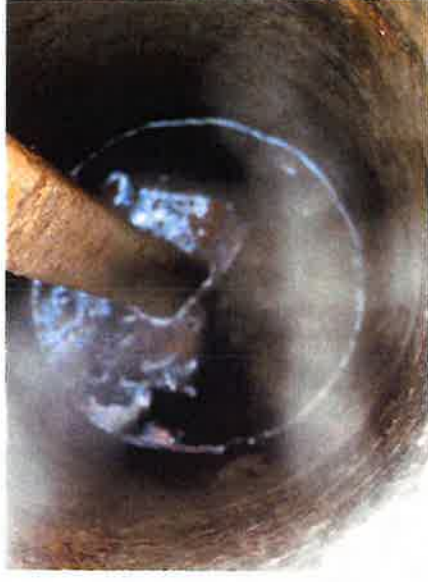
Miller Creek Crossing  
Blowoff on wellfield line.  
Moving water in valve  
box indicating leakage.

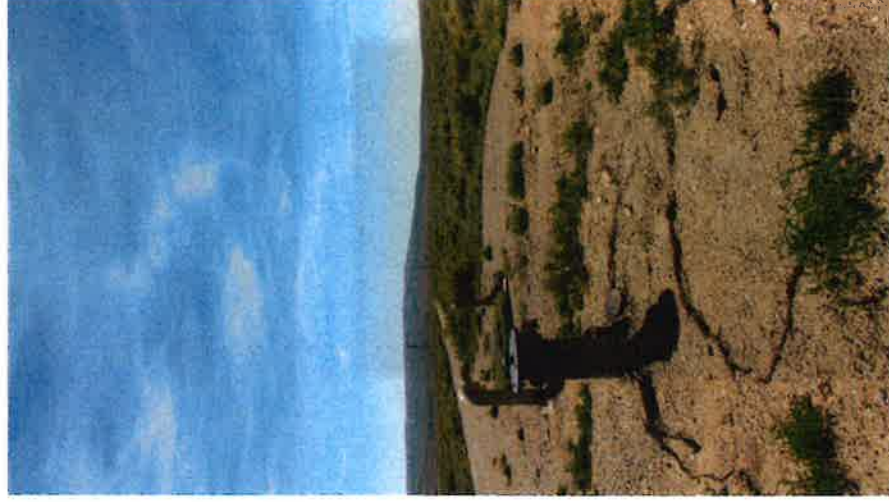
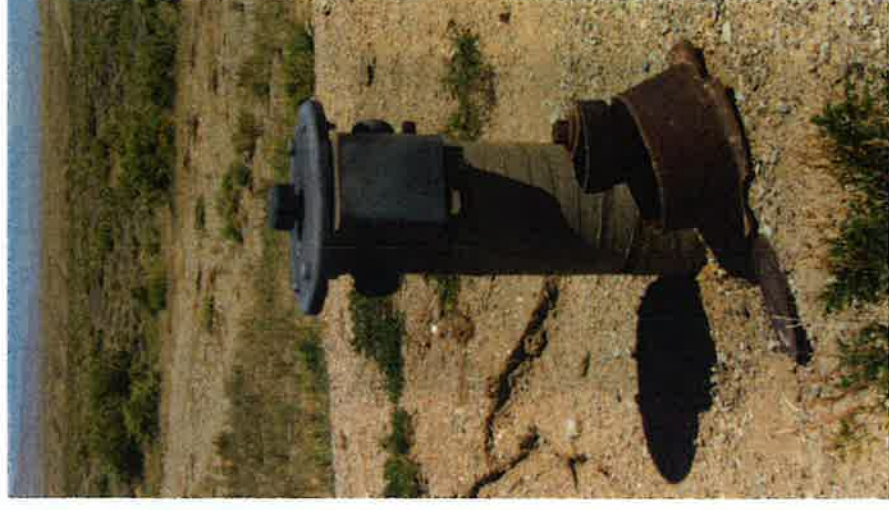
8/11/21  
Miller Hill Well  
No. 3  
View West  
Note Sinkhole

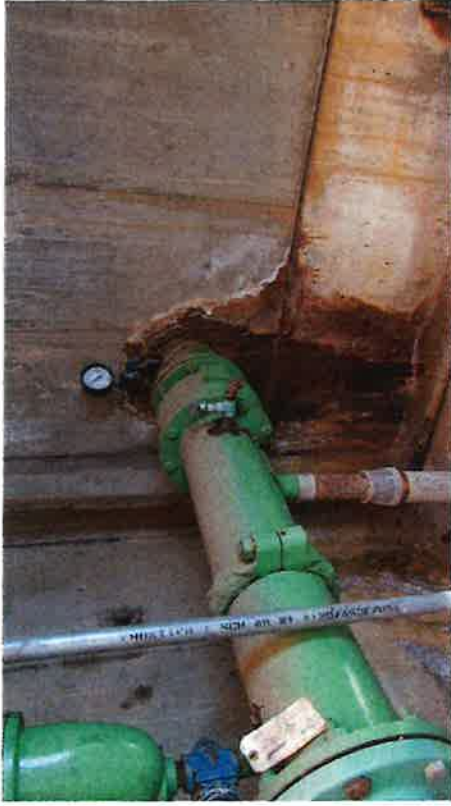
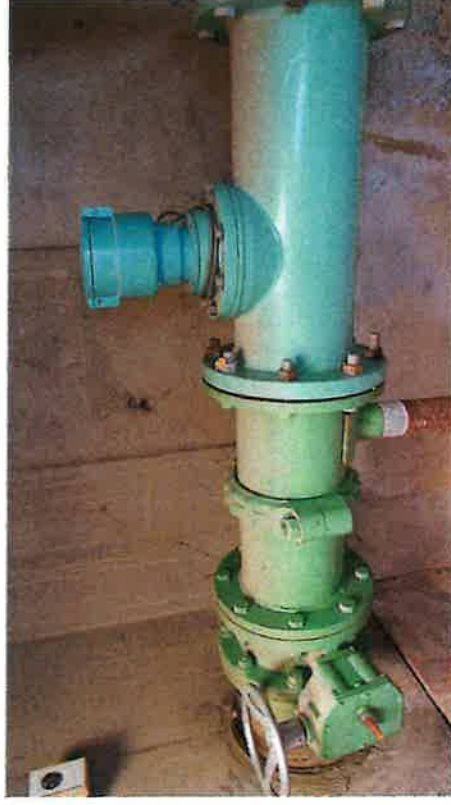
8/11/21  
Miller Hill Well No. 3  
Very little flow, but on.

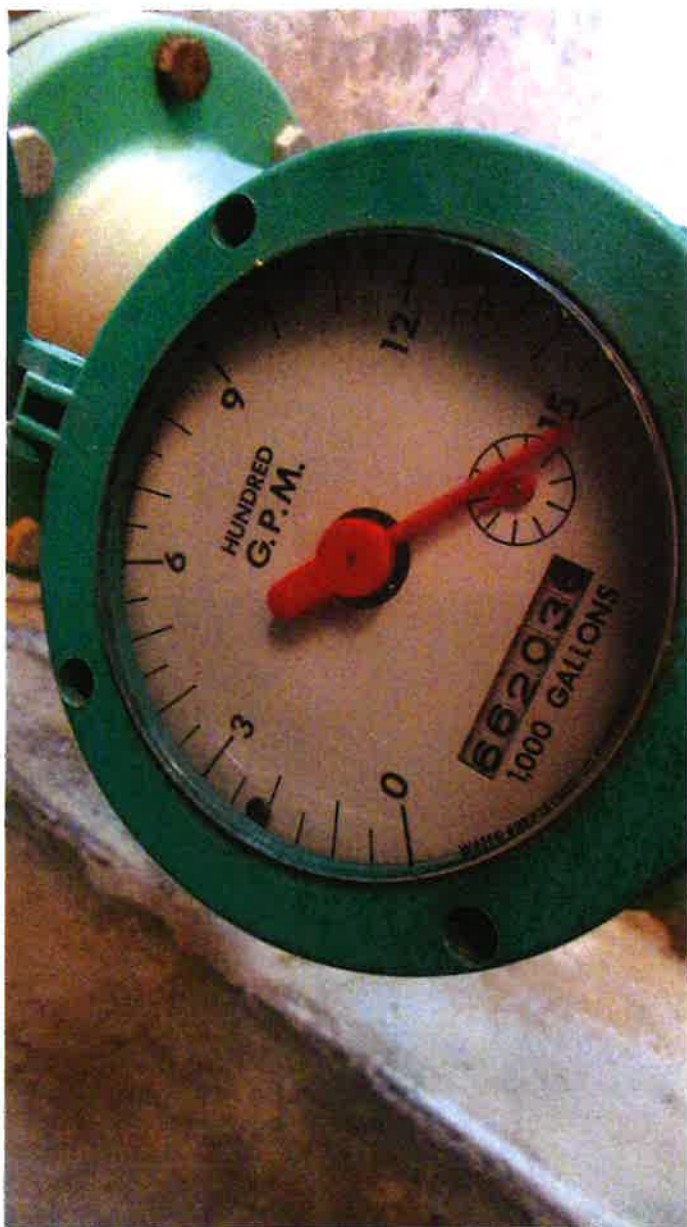
8/11/21  
Miller Hill Well No. 1  
Erratic movements on Water Meter

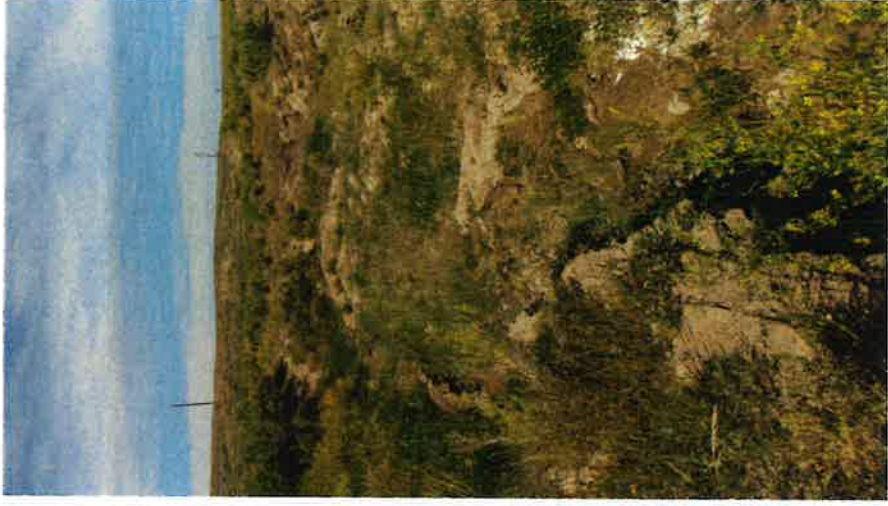
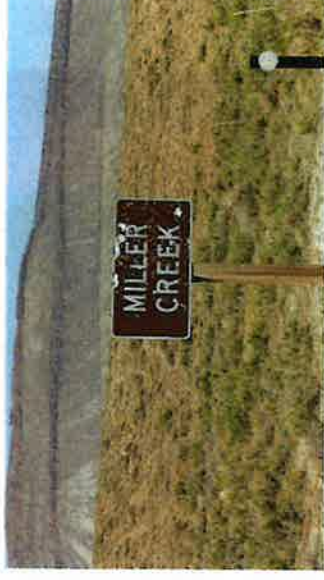
8/11/21  
Miller Creek  
Crossing on West  
Side of Hwy 71  
Leaking Blowoff

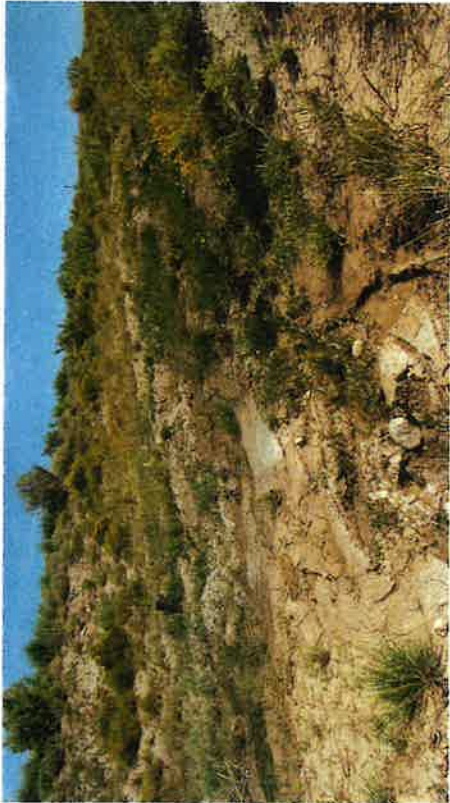
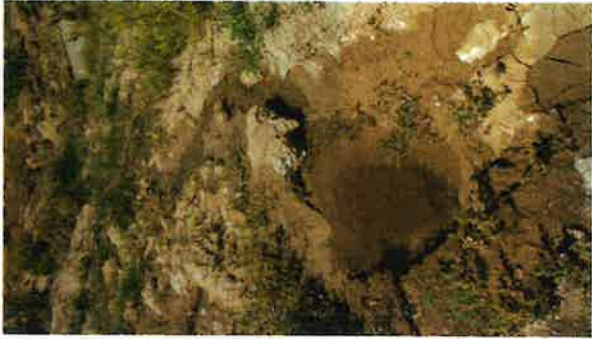
8/11/21  
Miller Creek Crossing on West Side of Hwy 71  
Leaking Blowoff

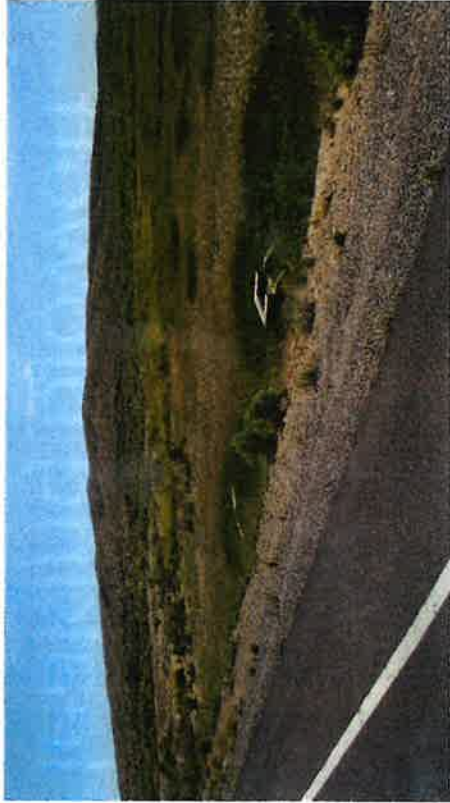
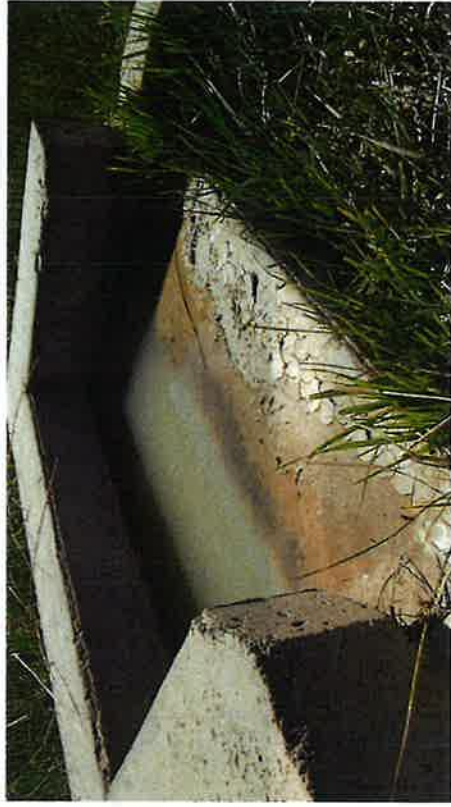
Little Sage Creek  
leaking blowoff

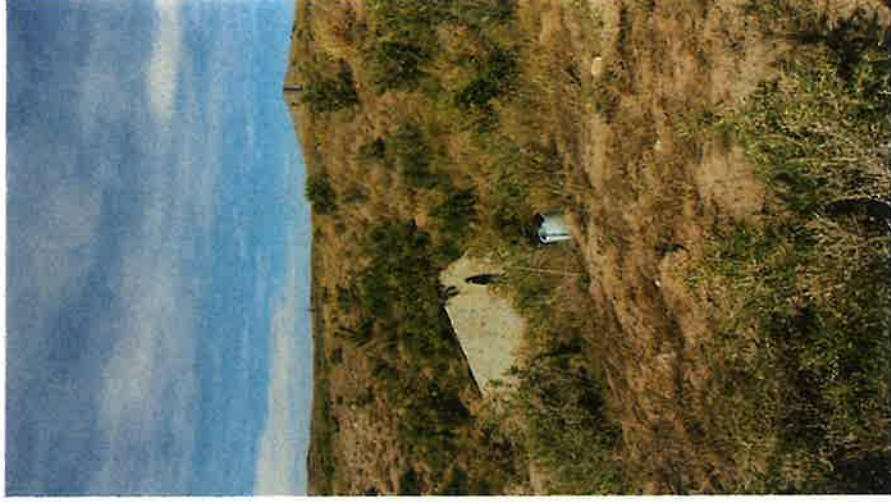
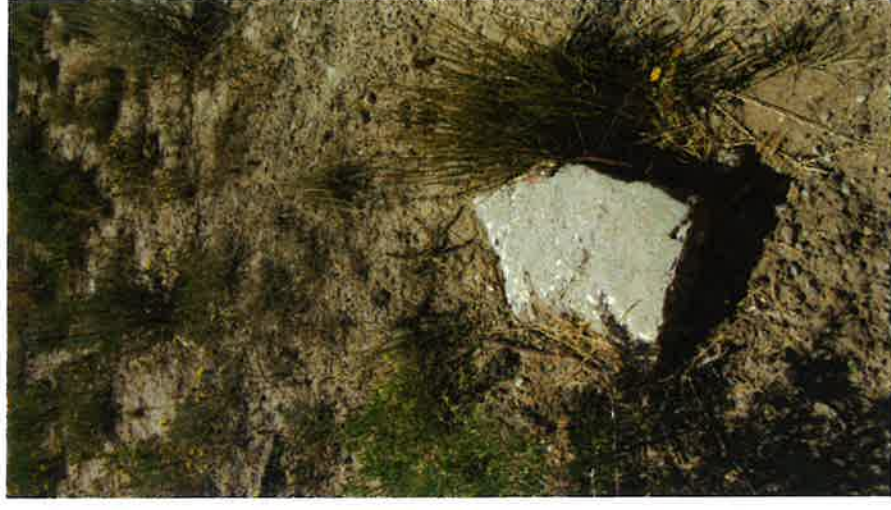
8/11/21  
Broken valve box and  
concrete fragments  
at creek crossing

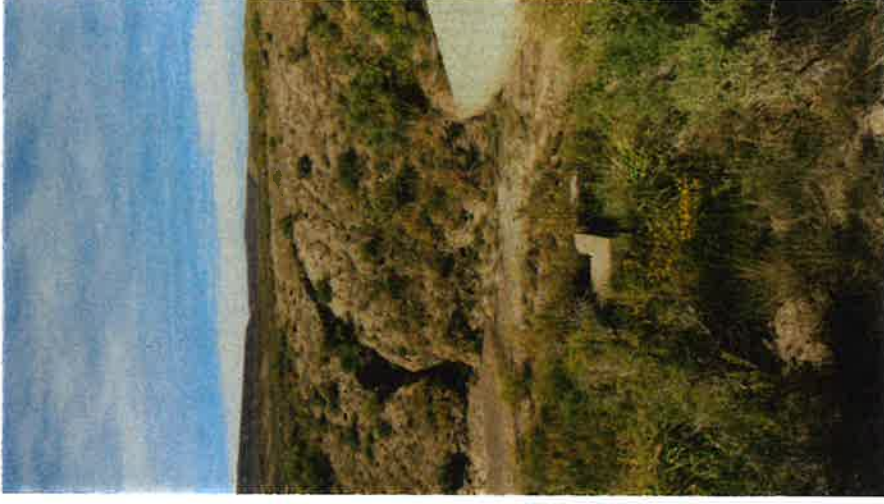
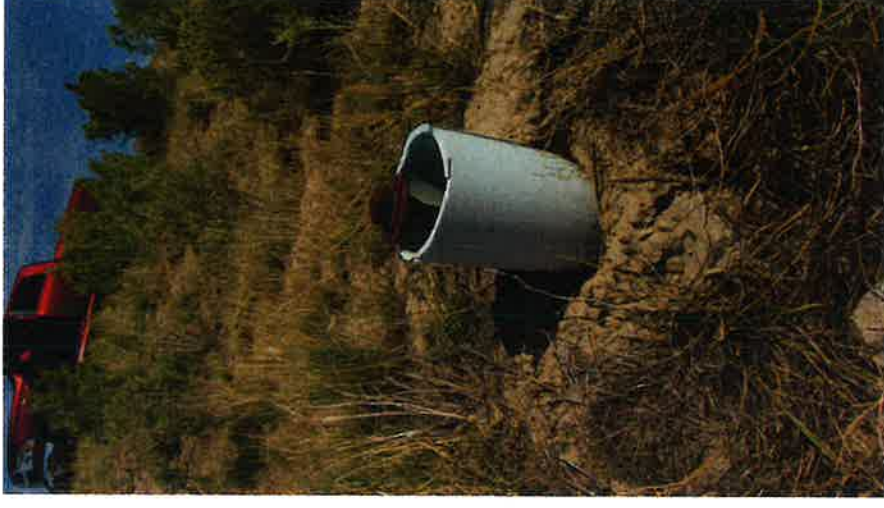
8/11/21  
Broken valve box and  
concrete fragments  
at creek crossing

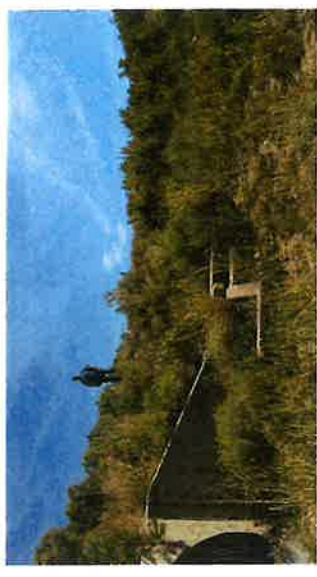
8/11/21  
Broken valve box and concrete fragments at  
creek crossing
