SAGE CREEK SPRINGS WORKSHOP

TOUR OF THE RAWLINS WATER SUPPLY

## RAWLINS GROUNDWATER SUPPLY FIELD VISIT AGENDA

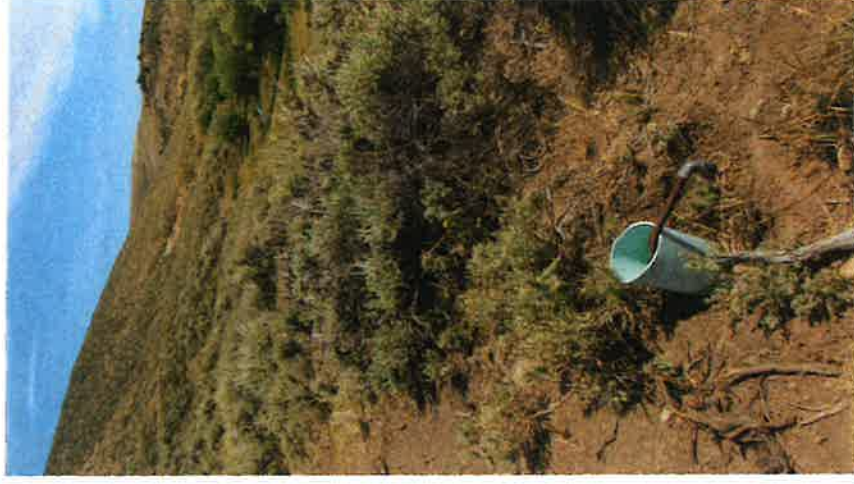
8/11/21  
Rawlins  
Reservoir view  
from Dam to  
West and  
Damaged  
Outlet Tower

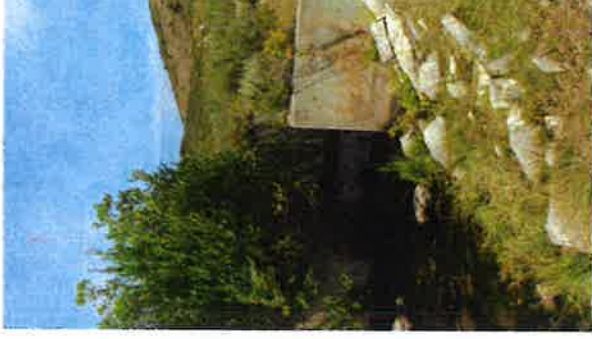
8/11/21  
East side of Rawlins Reservoir outlet pipes.

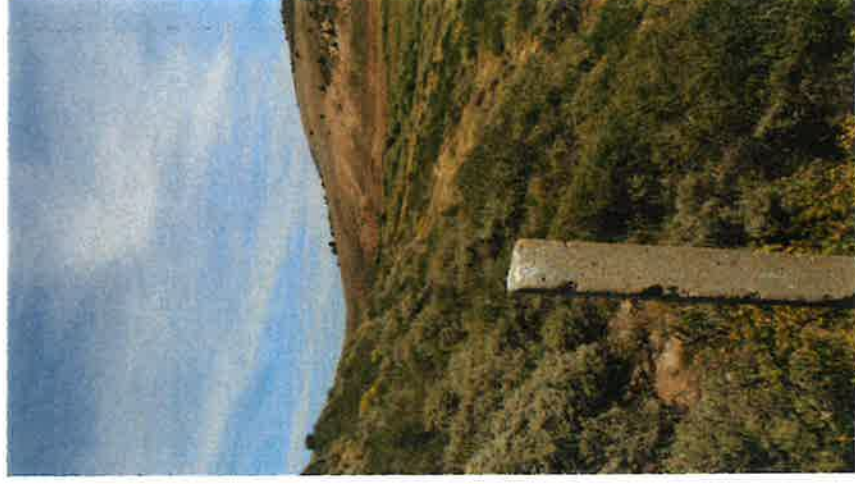
8/11/21  
Marker on East  
side of Rawlins  
Reservoir  
Embankment.  
May be Sage  
Creek line to  
junction.  
View West

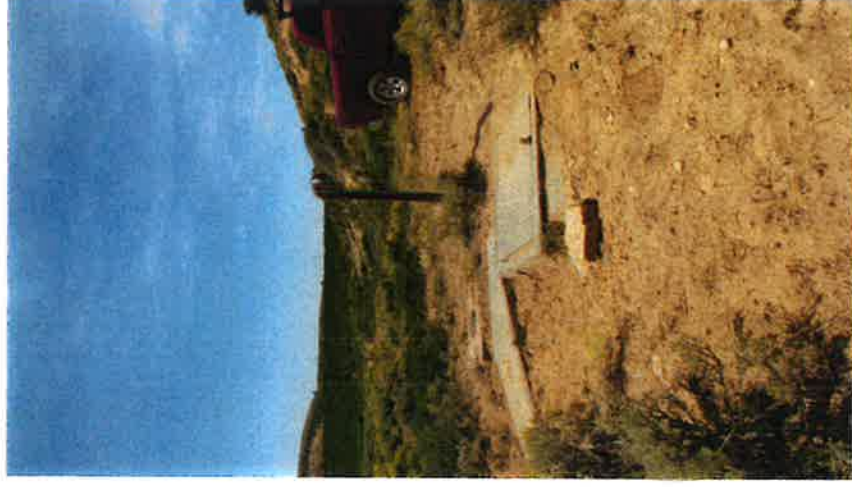
8/11/21  
Junction box  
Sage Creek right  
side Beaver  
Creek left side.  
Total Flow  
1.435MGD

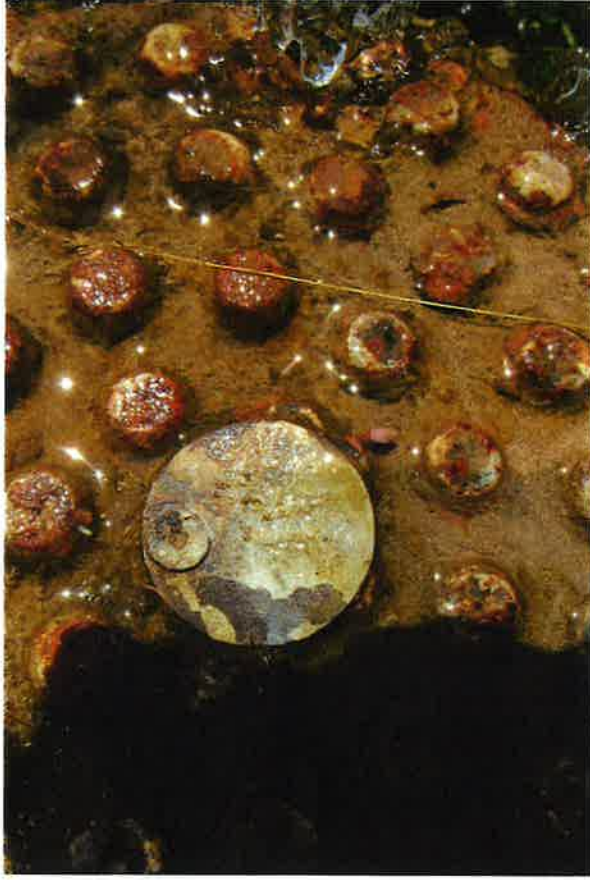
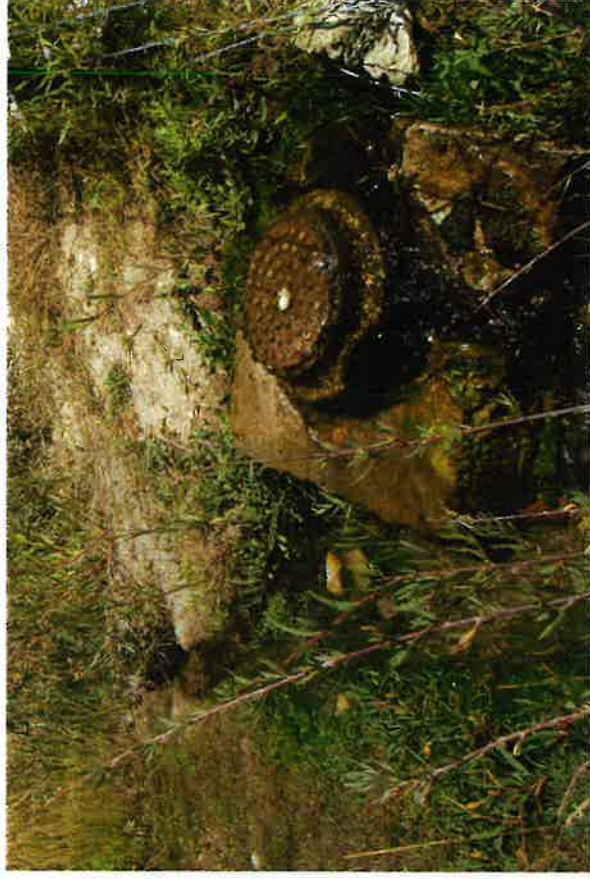
8/11/21  
Leak?  
Below junction  
box Sage &  
Beaver Creeks.  
Pipe is vault  
spillway.  
View SW

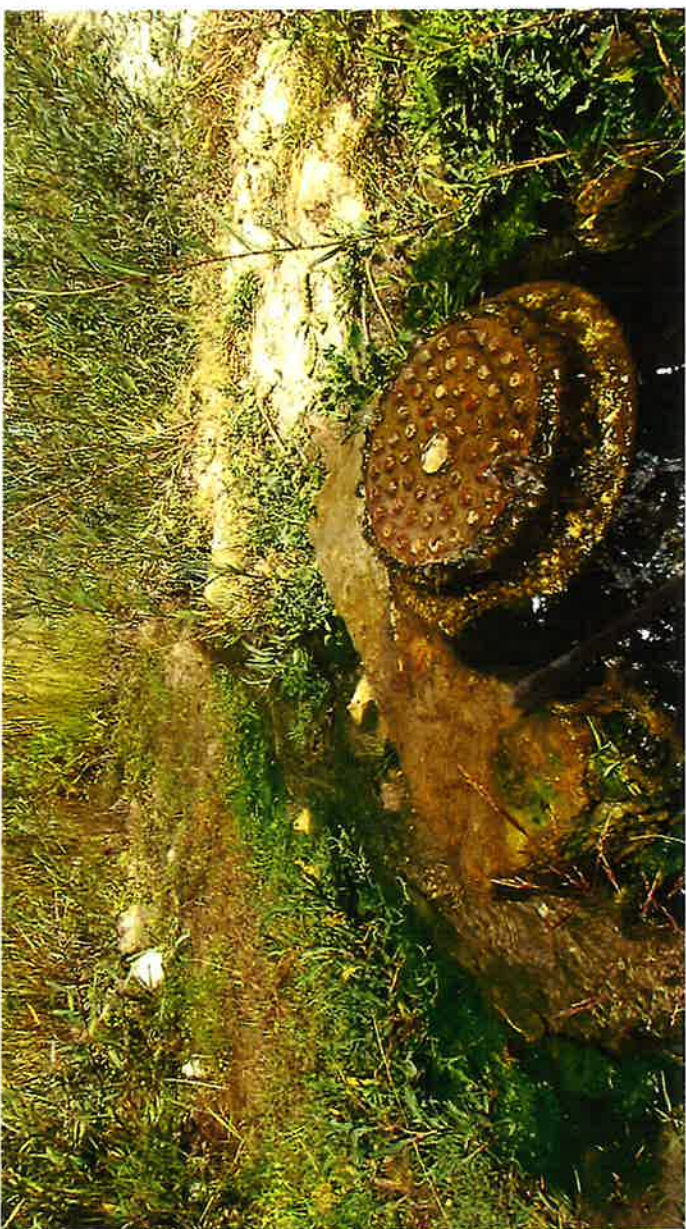
8/11/21  
Lone Tree Creek Blowoff Valve  
Illegible valve number.

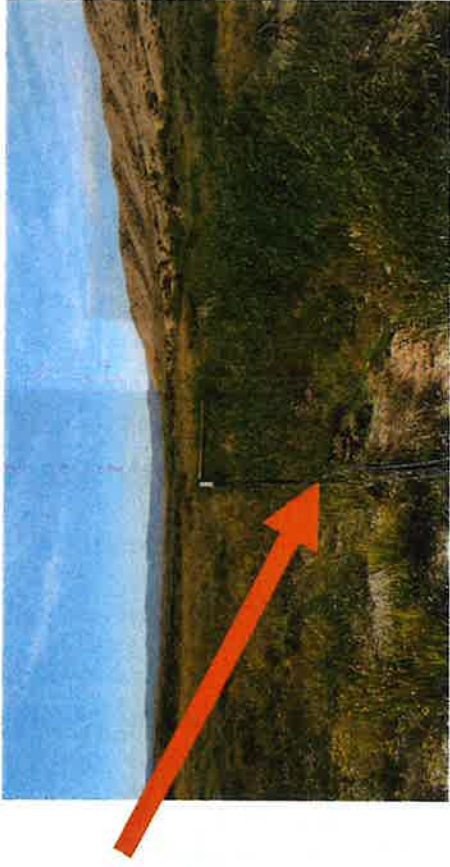
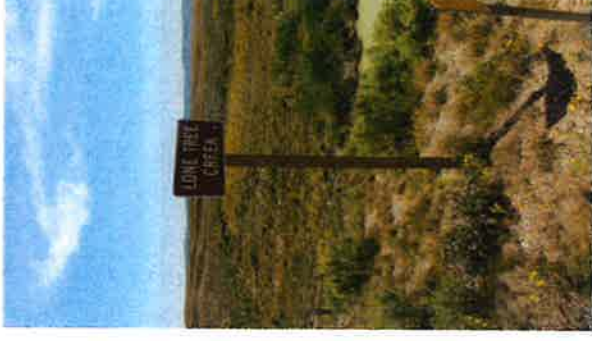
8/11/21  
Lone Tree Creek Blowoff Valve

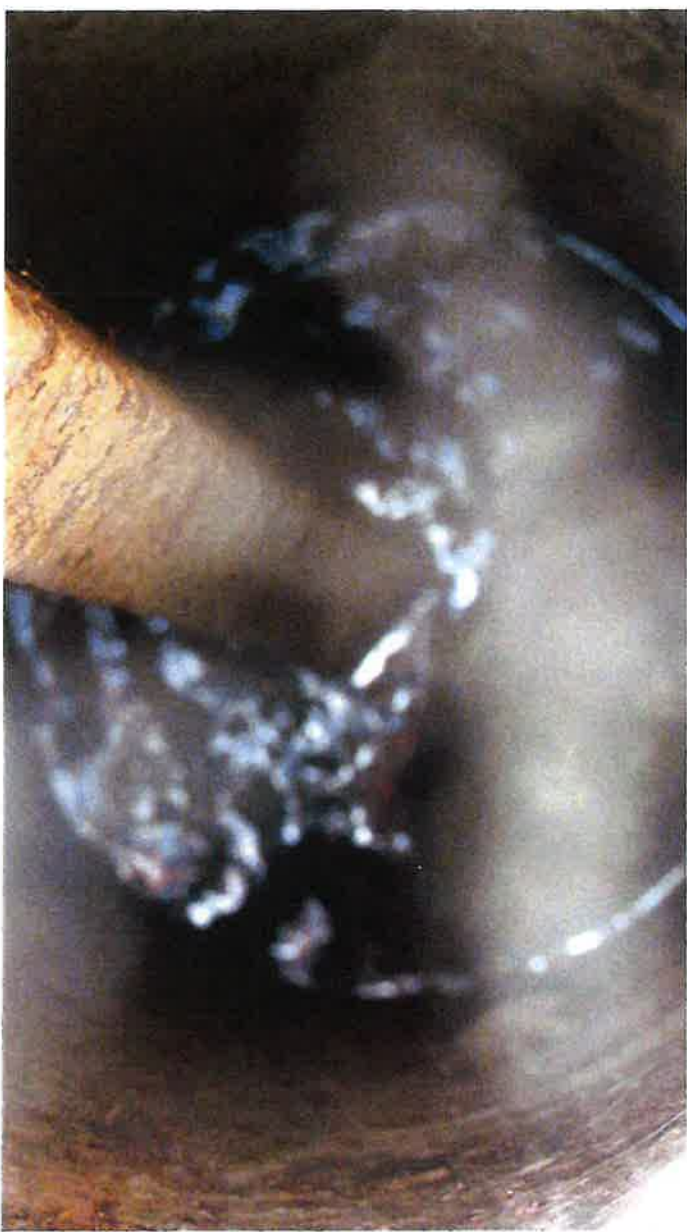
Miller Creek Crossing  
Blowoff on wellfield line.  
Moving water in valve  
box indicating leakage.

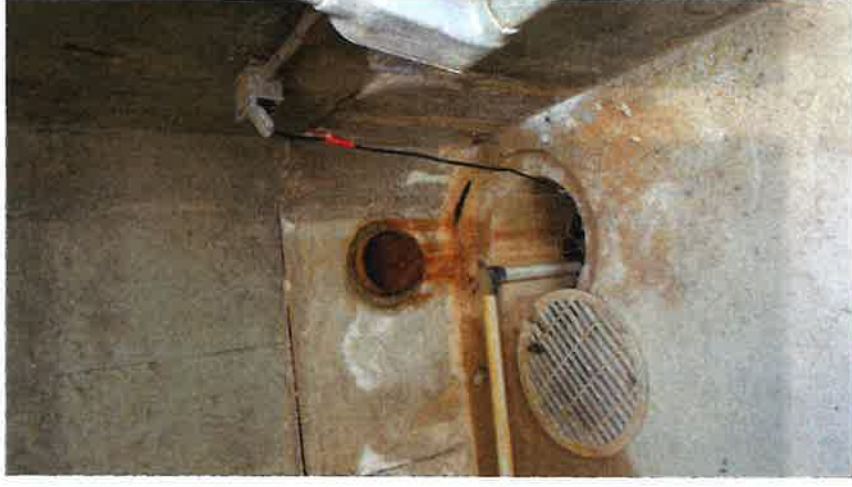
Typical floor  
sump at all  
wells.

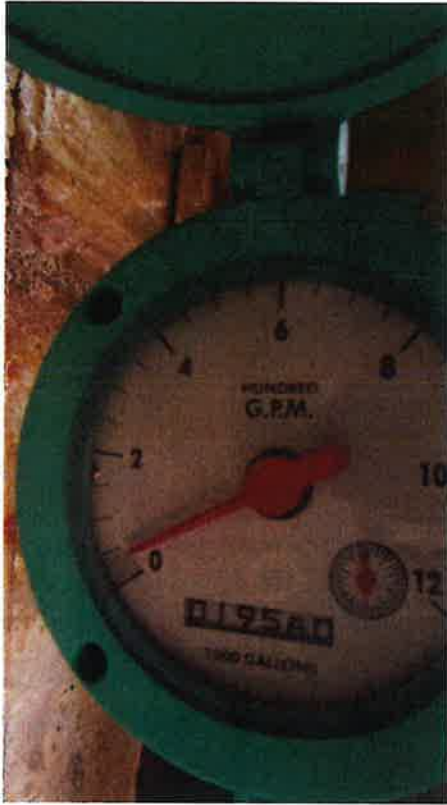
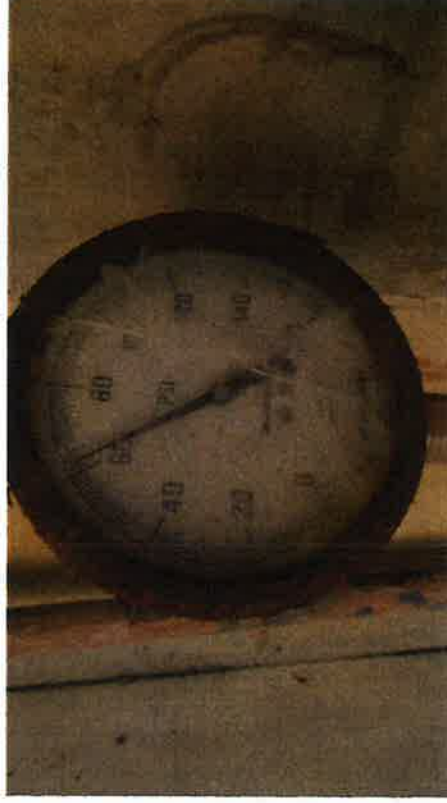
8/11/21  
Miller Hill Well No. 3  
Very little flow, but on.

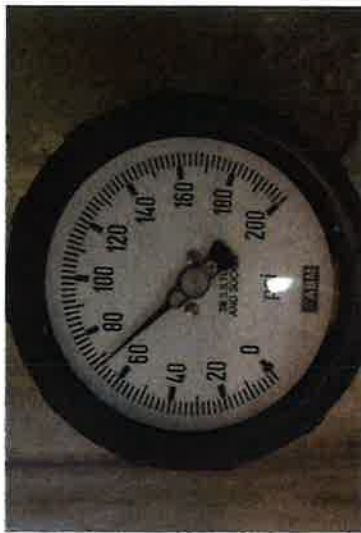
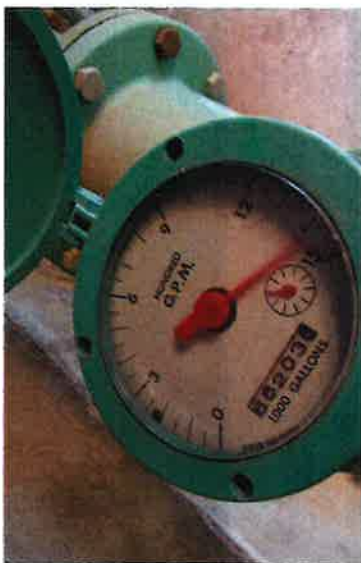
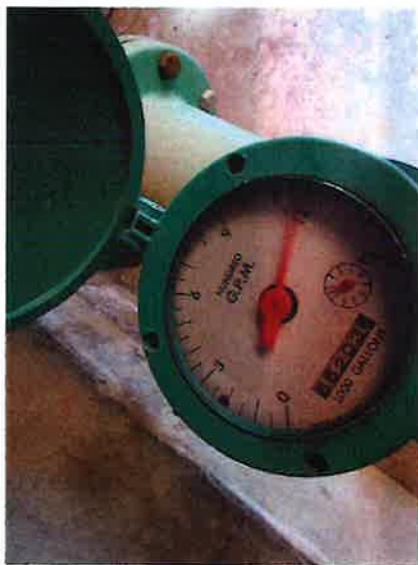
8/11/21  
Miller Hill Well No. 1  
Erratic movements on Water Meter

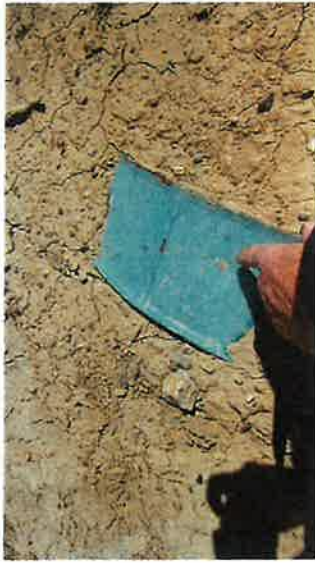
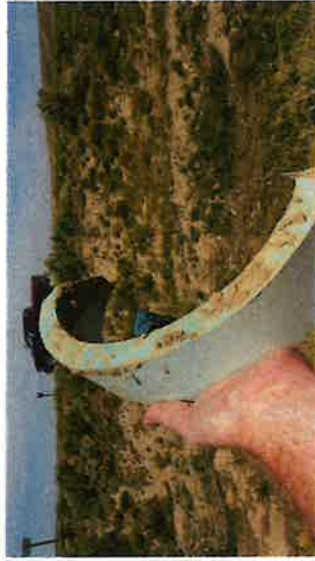
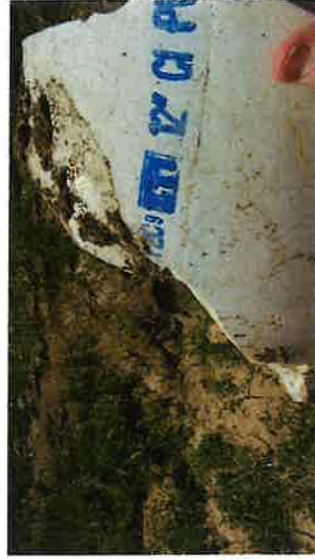
8/11/21  
Miller Creek  
Crossing on West  
Side of Hwy 71  
Leaking Blowoff

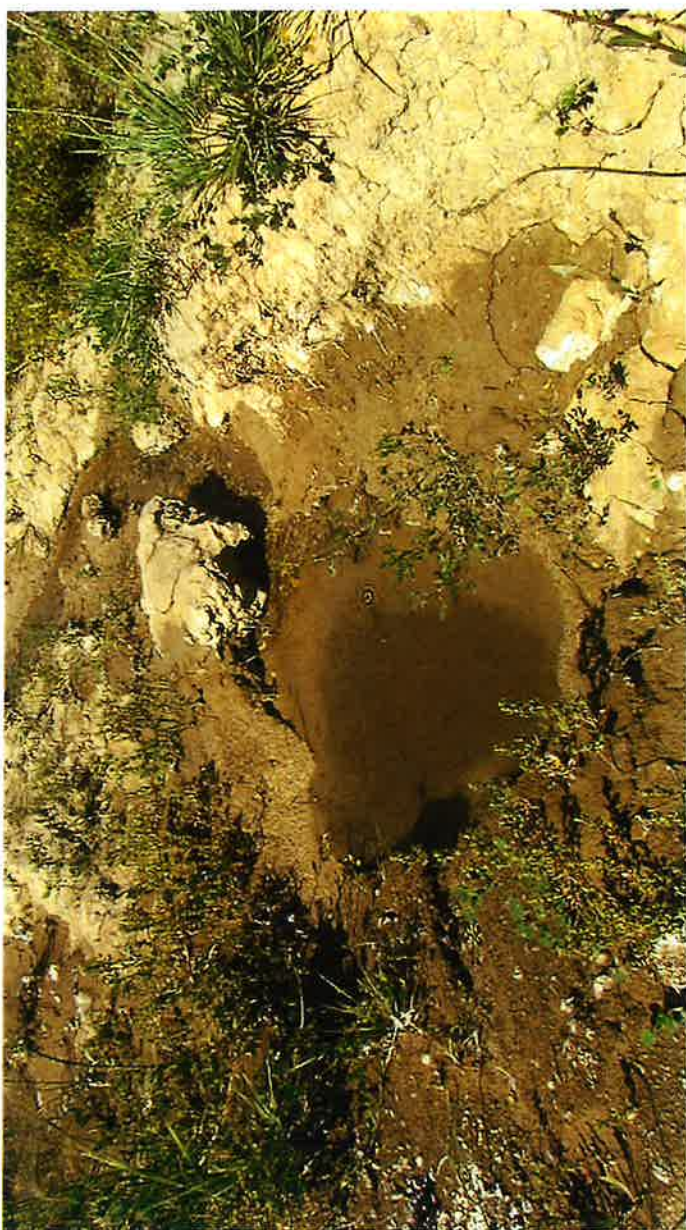
8/11/21  
Miller Creek Crossing on West Side of Hwy 71  
Leaking Blowoff

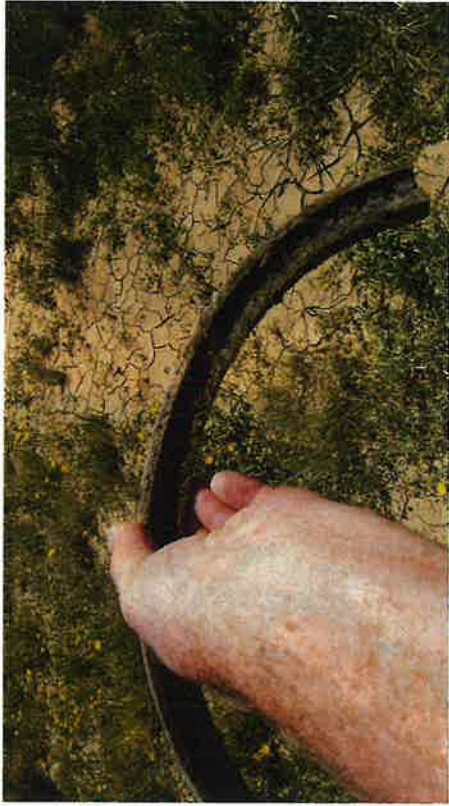
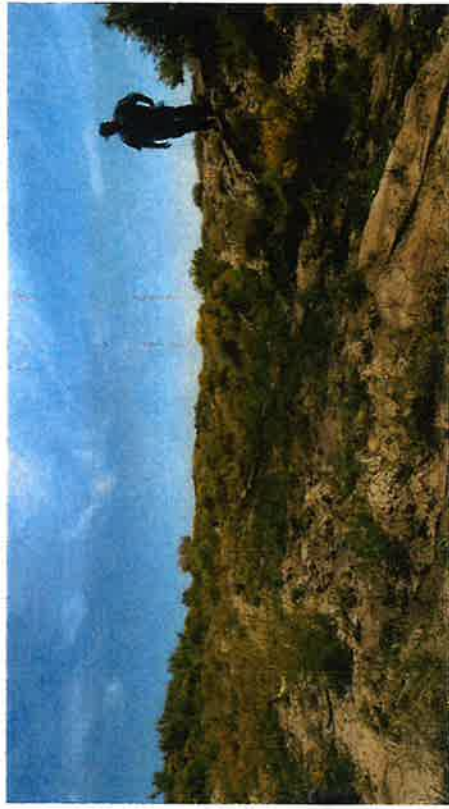
8/11/21  
Miller Creek Crossing on West Side of Hwy 71  
Leaking Blowoff
